Case Study: Jack-Up Rig Potable Water System Cleaning, Disinfection and Inspection

Following a period of cold stacking, we completed a full system review, disinfection and reinstatement prior to mobilisation.

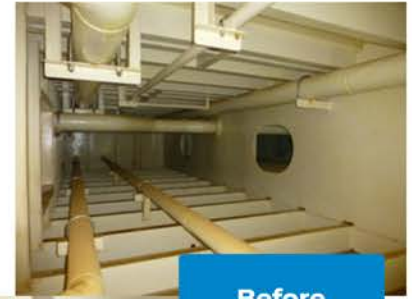
Before

- ✓ All tanks and gaskets found to be in good condition
- ✓ Remedial work required to tank coatings to prevent further damage
- ✓ Degraded sounding tube leading to excess deposits in the tank
- ✓ Microbiology, legionella and chemical testing reported as satisfactory
- ✓ Several small rust patches to be addressed before next tank clean

- ▶ Four rig potable water storage tanks were manually cleaned followed by spray disinfection
- ▶ A potable water storage tank was selected for the system disinfection and filled with a fresh water/AOB biocide mix.
